## **Limited Visual Dam Safety Inspections**

**Summary ReportA-085**

**HC&S Reservoir 80**

**Maui, Hawaii**

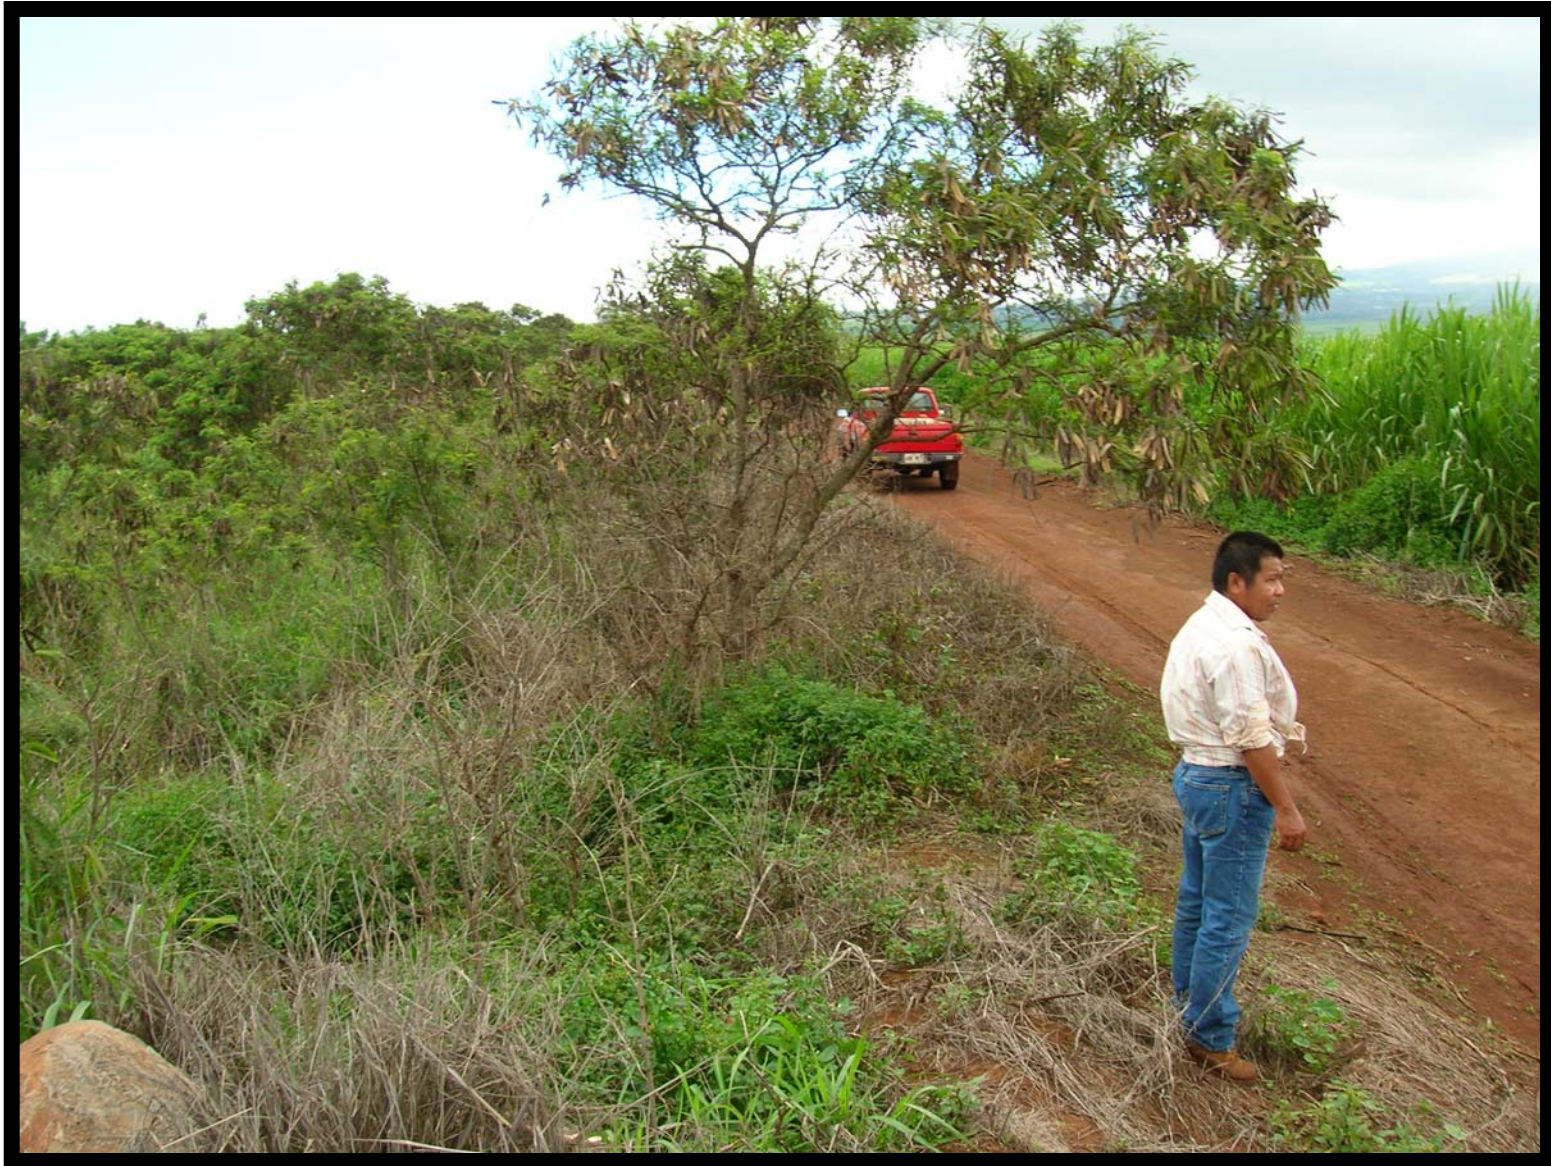
085 crest

Cracks were not observed, however the crest was not entirely visible.

Sinkholes were not observed, however the crest was not entirely visible.

Heavy vegetation was observed on the crest. These were primarily small woody vegetation and high grass.

- a. The dam crest appeared to be in fair to poor condition and requires corrective action.
- b. Portions of the crest were not visible due to high grass and bush vegetation. Clear high vegetation and maintain low to enable easy visual inspection.

- c. Tree(s) were observed along the dam crest. Trees have been identified as the probably cause of piping failures, and can possibly cause sever damage to the embankment if they are uprooted during a high winds. Corrective action is required to remove the tree hazards from the dam. Acceptable remedies include removal of the tree and its root structure down to a 2" diameter and reconstructing the damaged embankment section. All repair work shall be accomplished as per the requirements of licensed geotechnical or structural engineer. Routinely monitor the damaged area for signs of settlement and seepage.

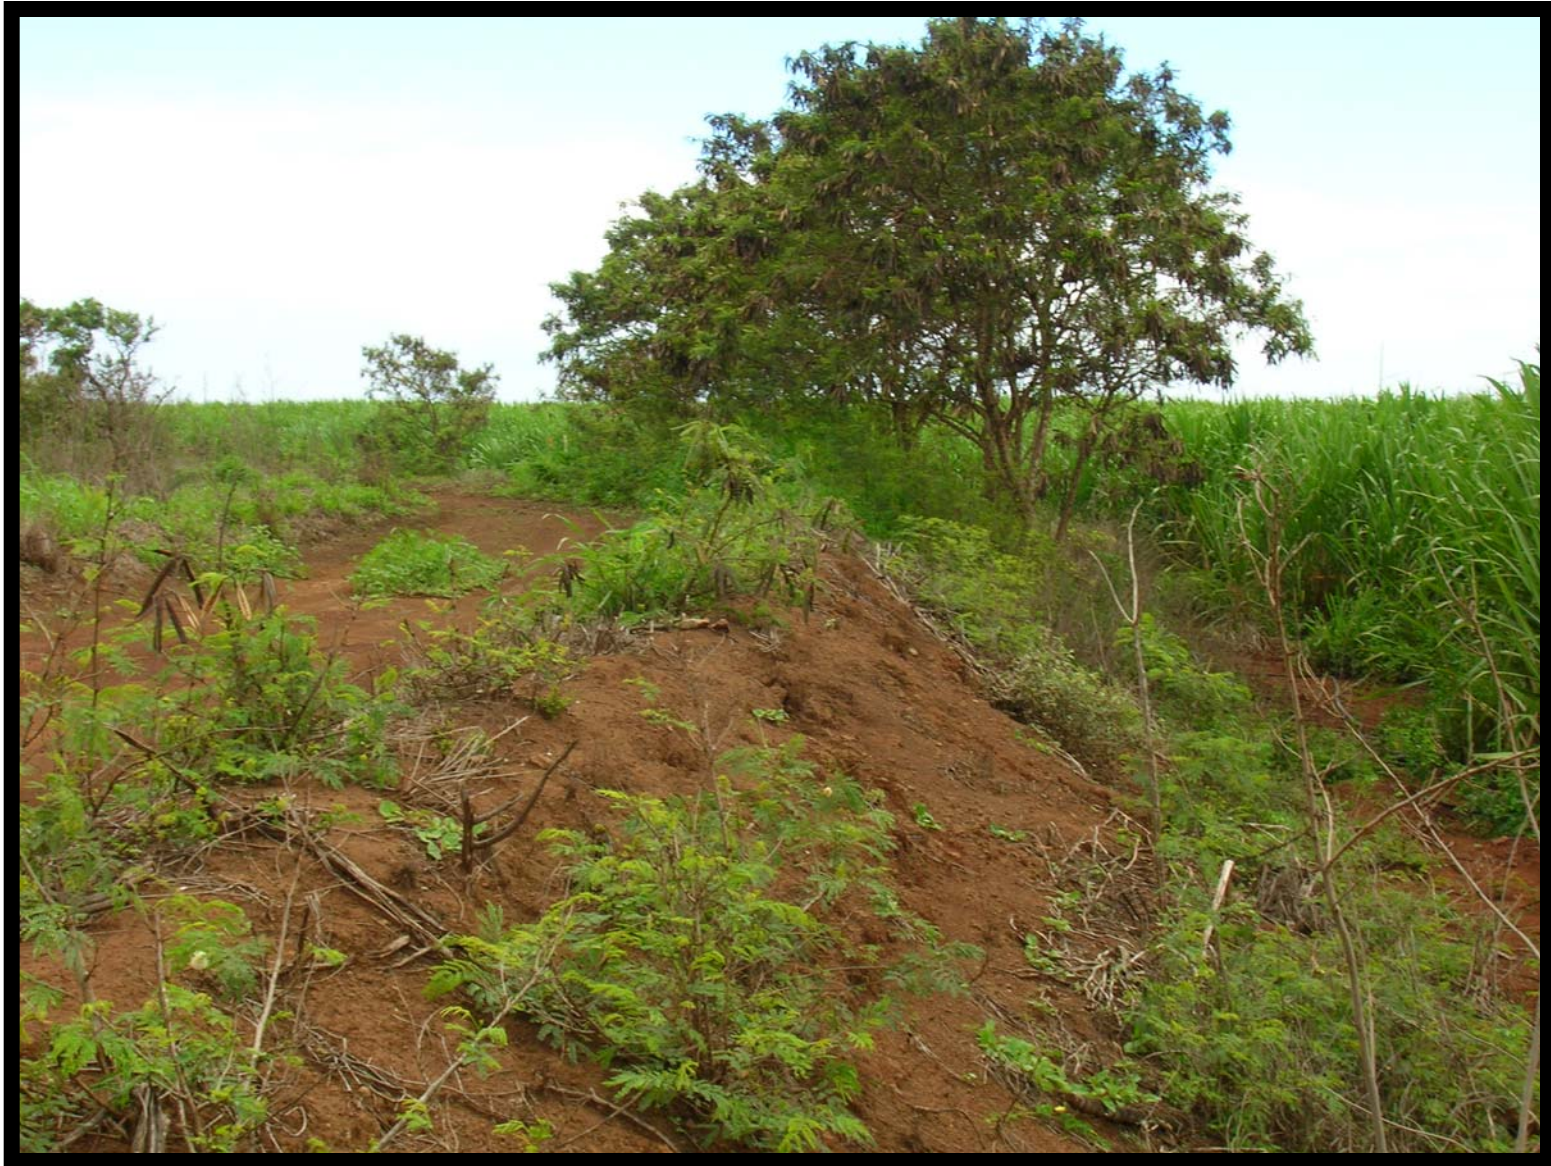
085 downstream slope

The downstream slope was in fair to poor condition and not visible due to heavy vegetation. The slope was a 1 on 2 slope.

There was no slope protection observed on the downstream slope.

Grasses, bushes and tress were observed on the downstream slope. .

- a. The downstream slope appeared to be in fair to poor condition and requires corrective action.
- b. The down stream slope was not visible due to high grass and bush vegetation. Clear high vegetation and maintain low to enable easy visual inspection.
- c. Tree(s) were observed on the downstream slope. Trees have been identified as the probably cause of piping failures, and can possibly cause sever damage to the embankment if they are uprooted during a high winds. Corrective action is required to remove the tree hazards from the dam. Acceptable remedies include removal of the tree and its root structure down to a 2" diameter and reconstructing the damaged embankment section. All repair work shall be accomplished as per the requirements of licensed geotechnical or structural engineer. Routinely monitor the damaged area for signs of settlement and seepage.

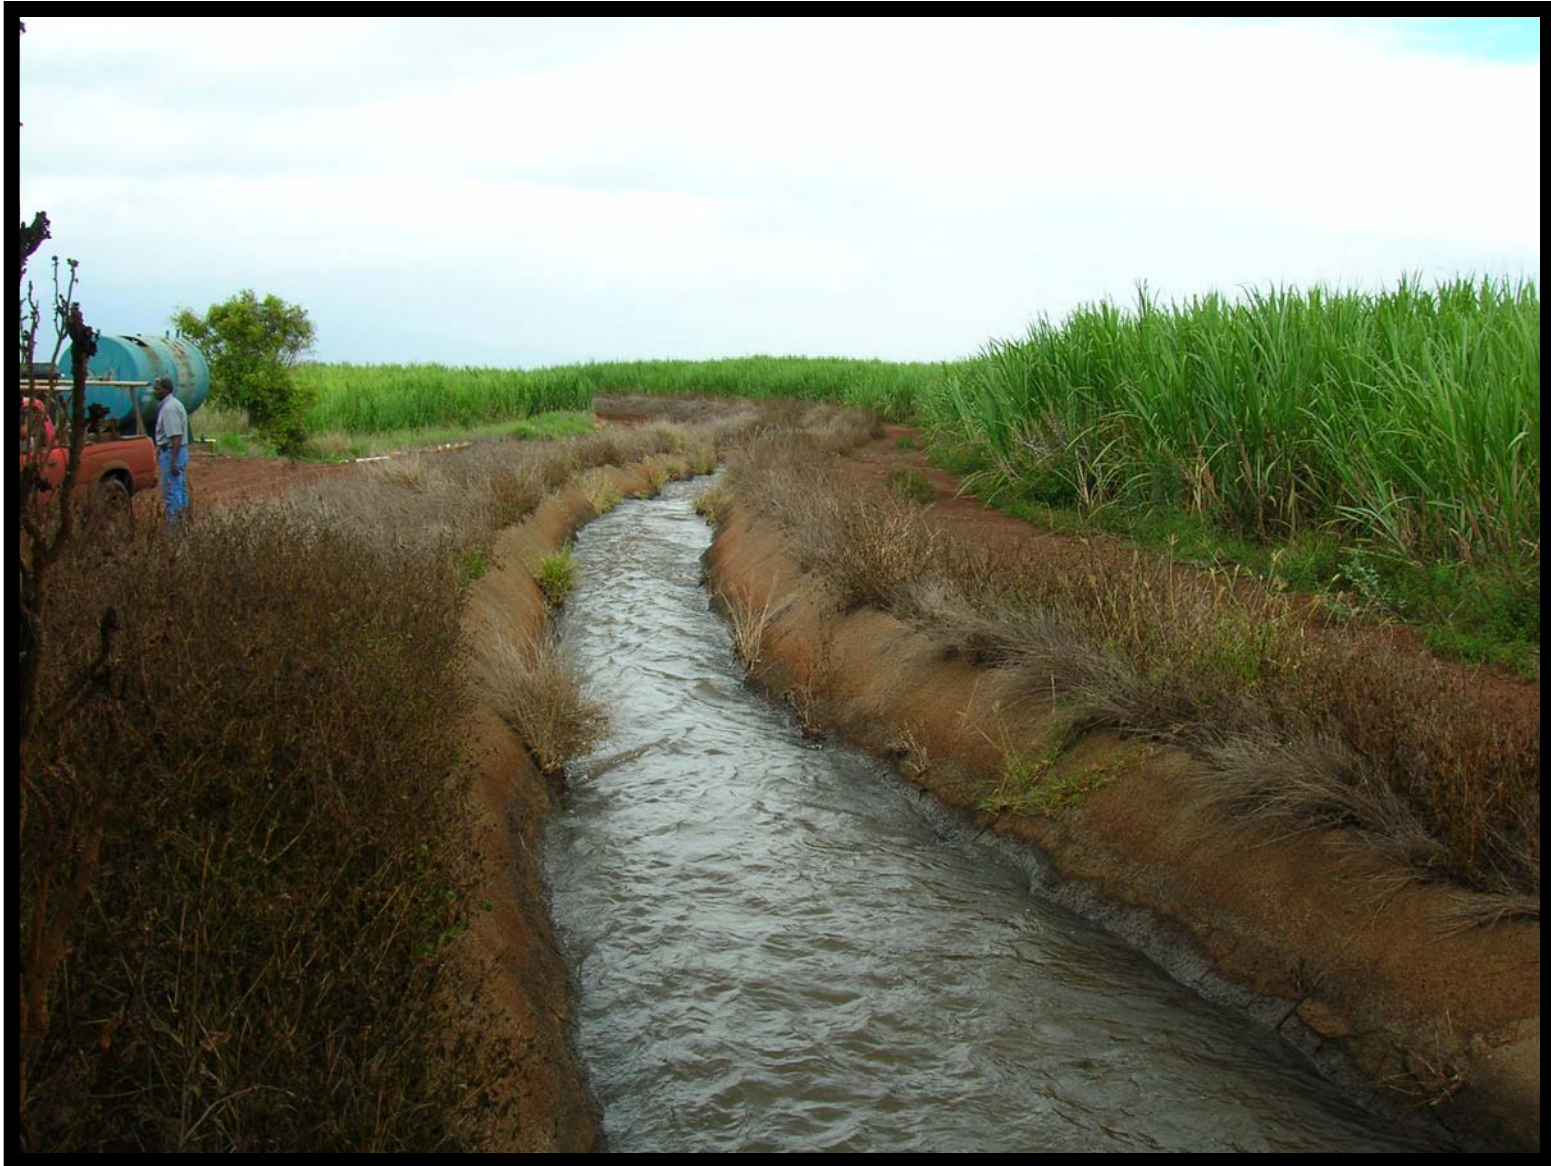
085 inlet

- a. The intake works were not tested.
- b. The intake works appeared to be in satisfactory condition, no corrective actions are required at this time.

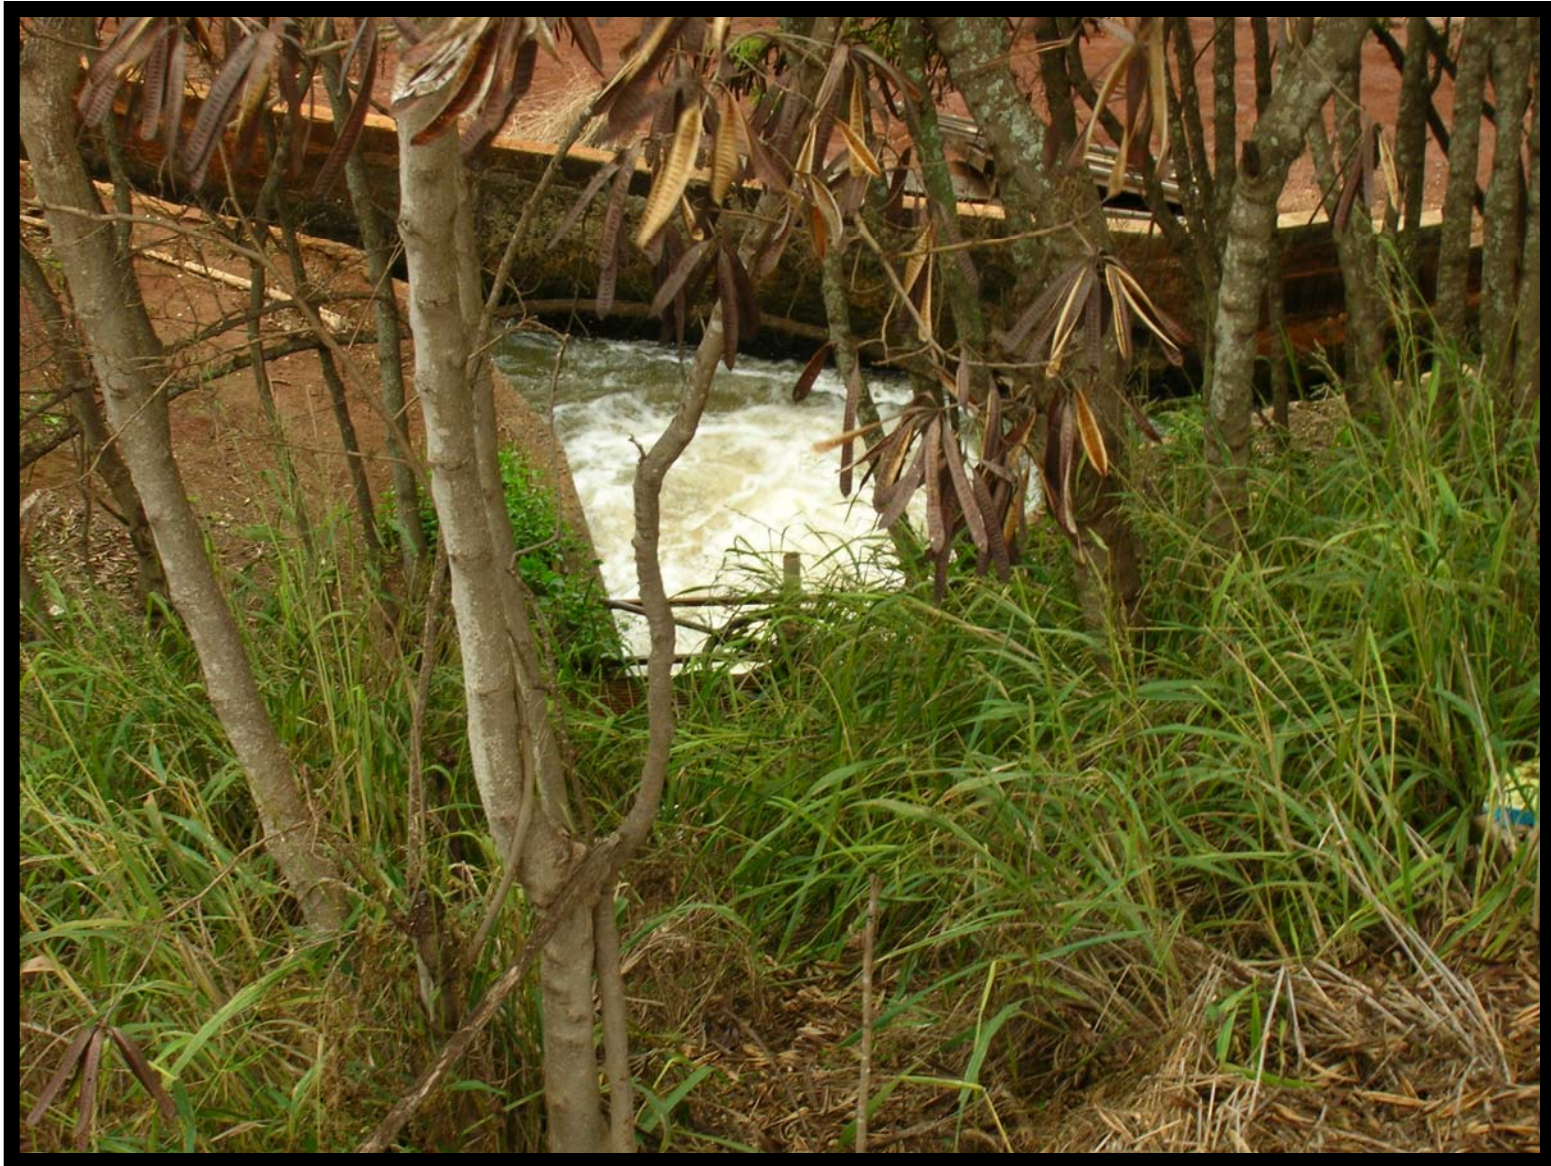
085 outlet

- a. The outlet works were not tested.
- b. The outlet works appeared to be in satisfactory condition, no corrective actions are required at this time.

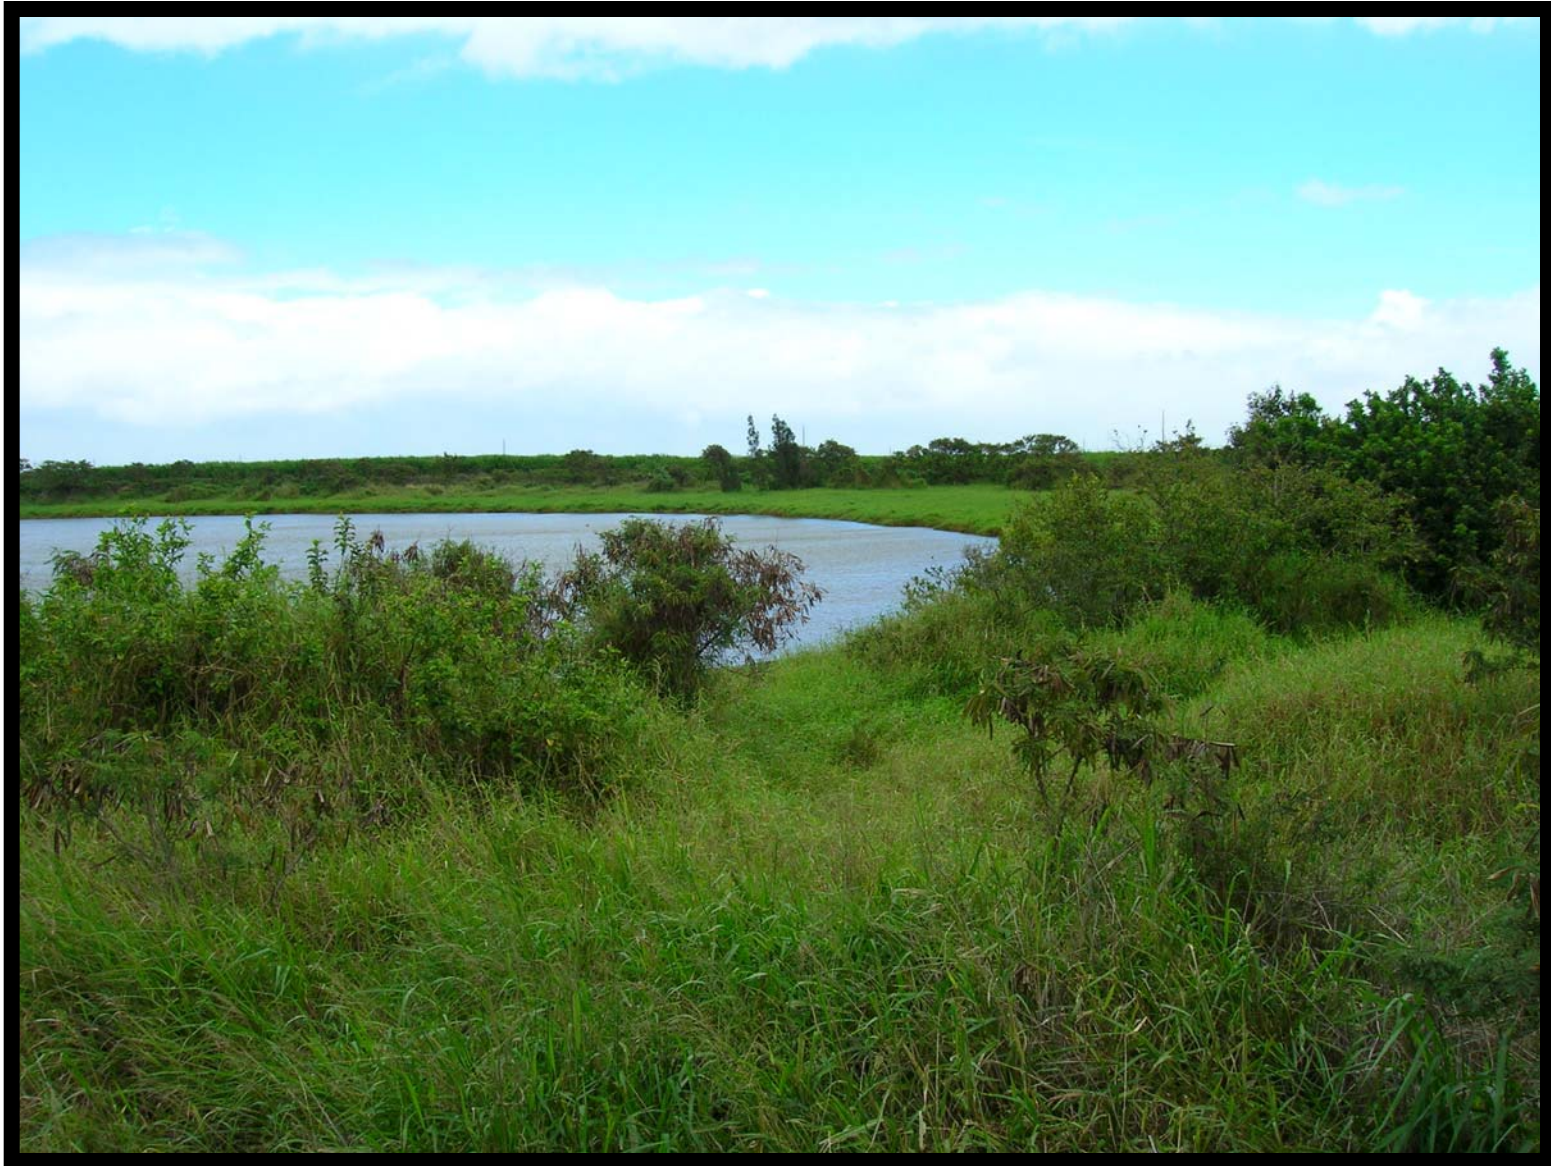
085 reservoir

- a. The reservoir appeared to be in satisfactory condition, no corrective actions are required at this time.

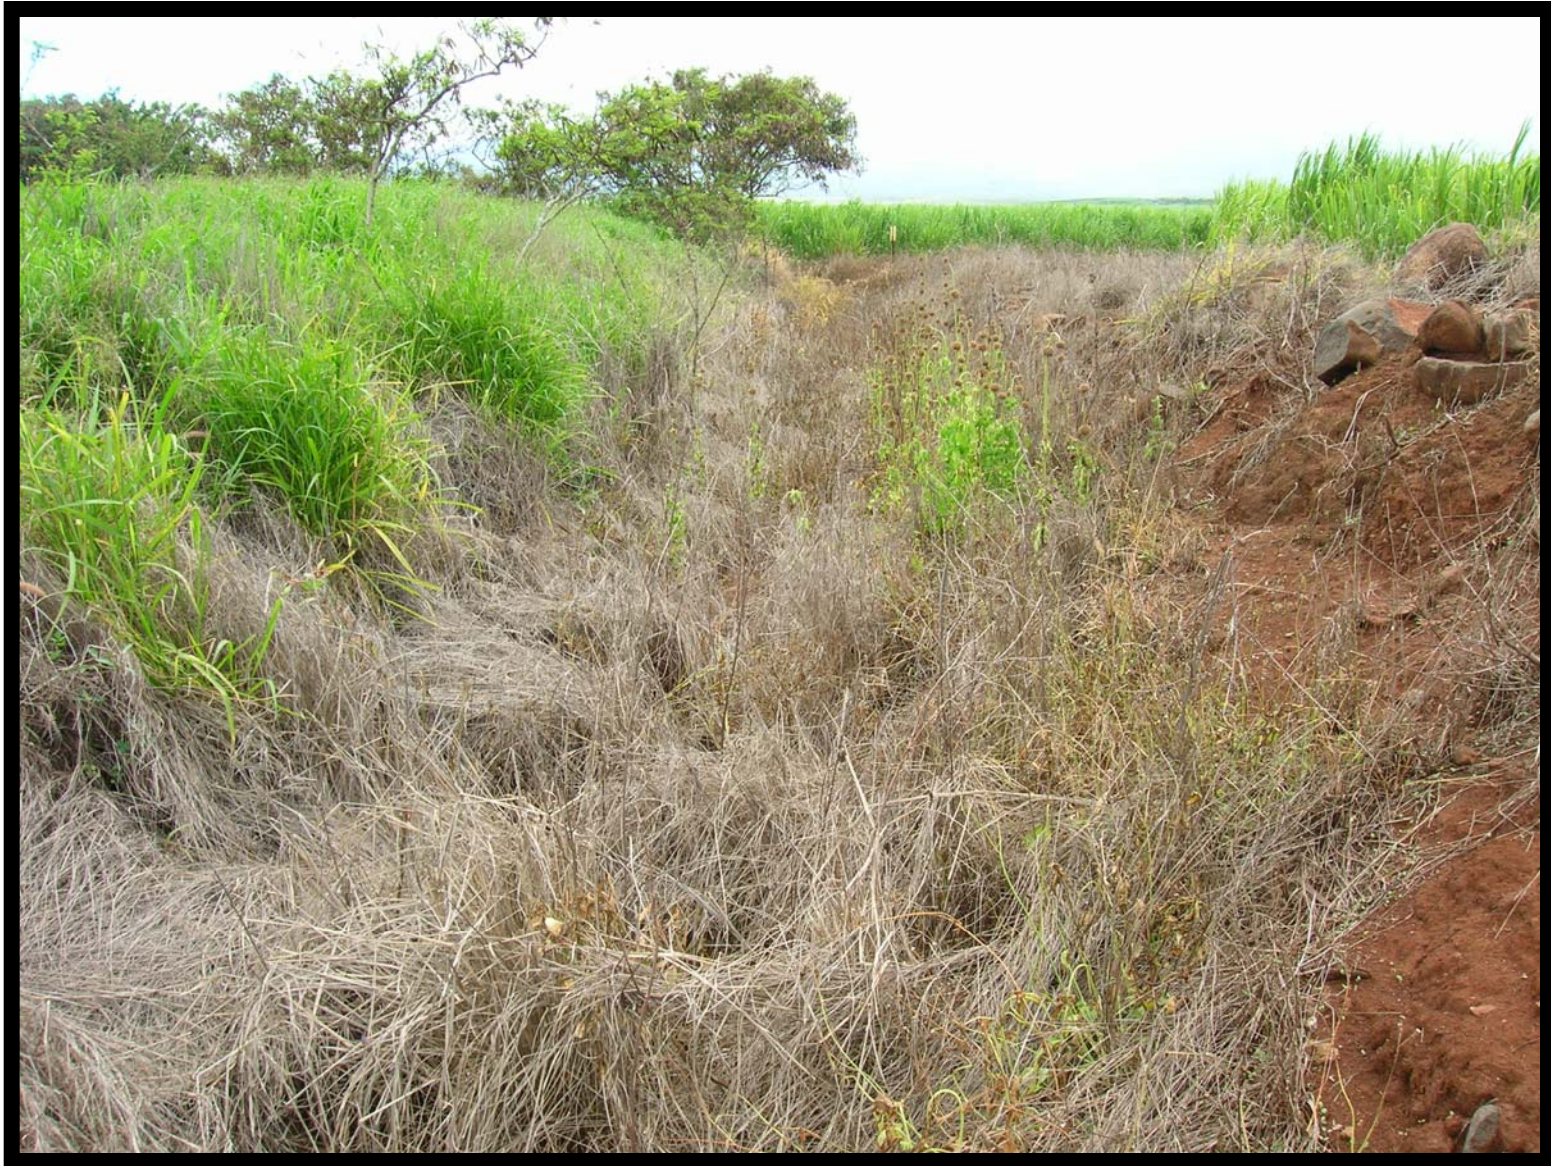
085 spillway channel

- a. The downstream channel was not inspected.
- b. The downstream channel appeared to be in fair to poor condition and requires corrective action.
- c. Clean silt from channel culvert.

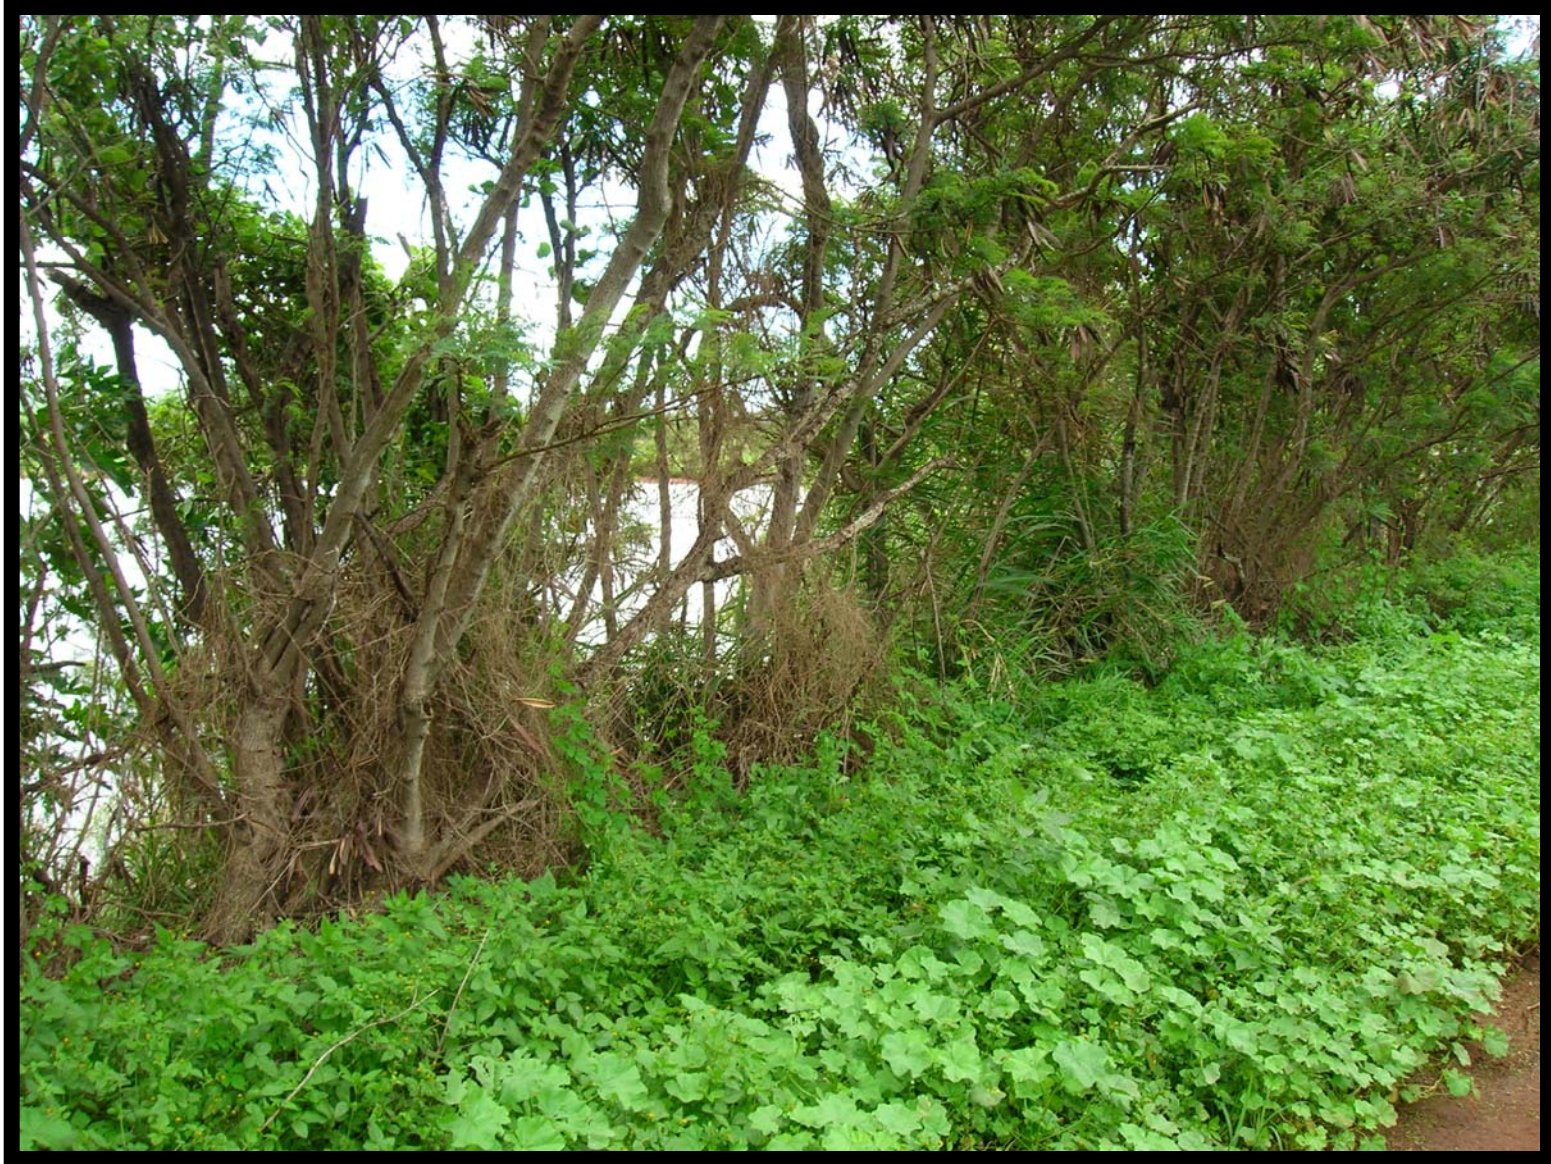
085 upstream slope

A fitted rip rap rock slope protection was observed. Vegetation was observed growing between the rocks.

Cracks were not visible; the slope was not entirely visible.

- a. The upstream slope appeared to be in fair to poor condition and requires corrective action.
- b. The upstream slope was not visible due to high grass and bush vegetation. Clear high vegetation and maintain low to enable easy visual inspection.
- c. Tree(s) were observed on the dam embankment. Trees have been identified as the probably cause of piping failures, and can possibly cause sever damage to the embankment if they are uprooted during a high winds. Corrective action is required to remove the tree hazards from the dam. Acceptable remedies include removal of the tree and its root structure down to a 2" diameter and reconstructing the damaged embankment section. All repair work shall be accomplished as per the requirements of licensed geotechnical or structural engineer. Routinely monitor the damaged area for signs of settlement and seepage.

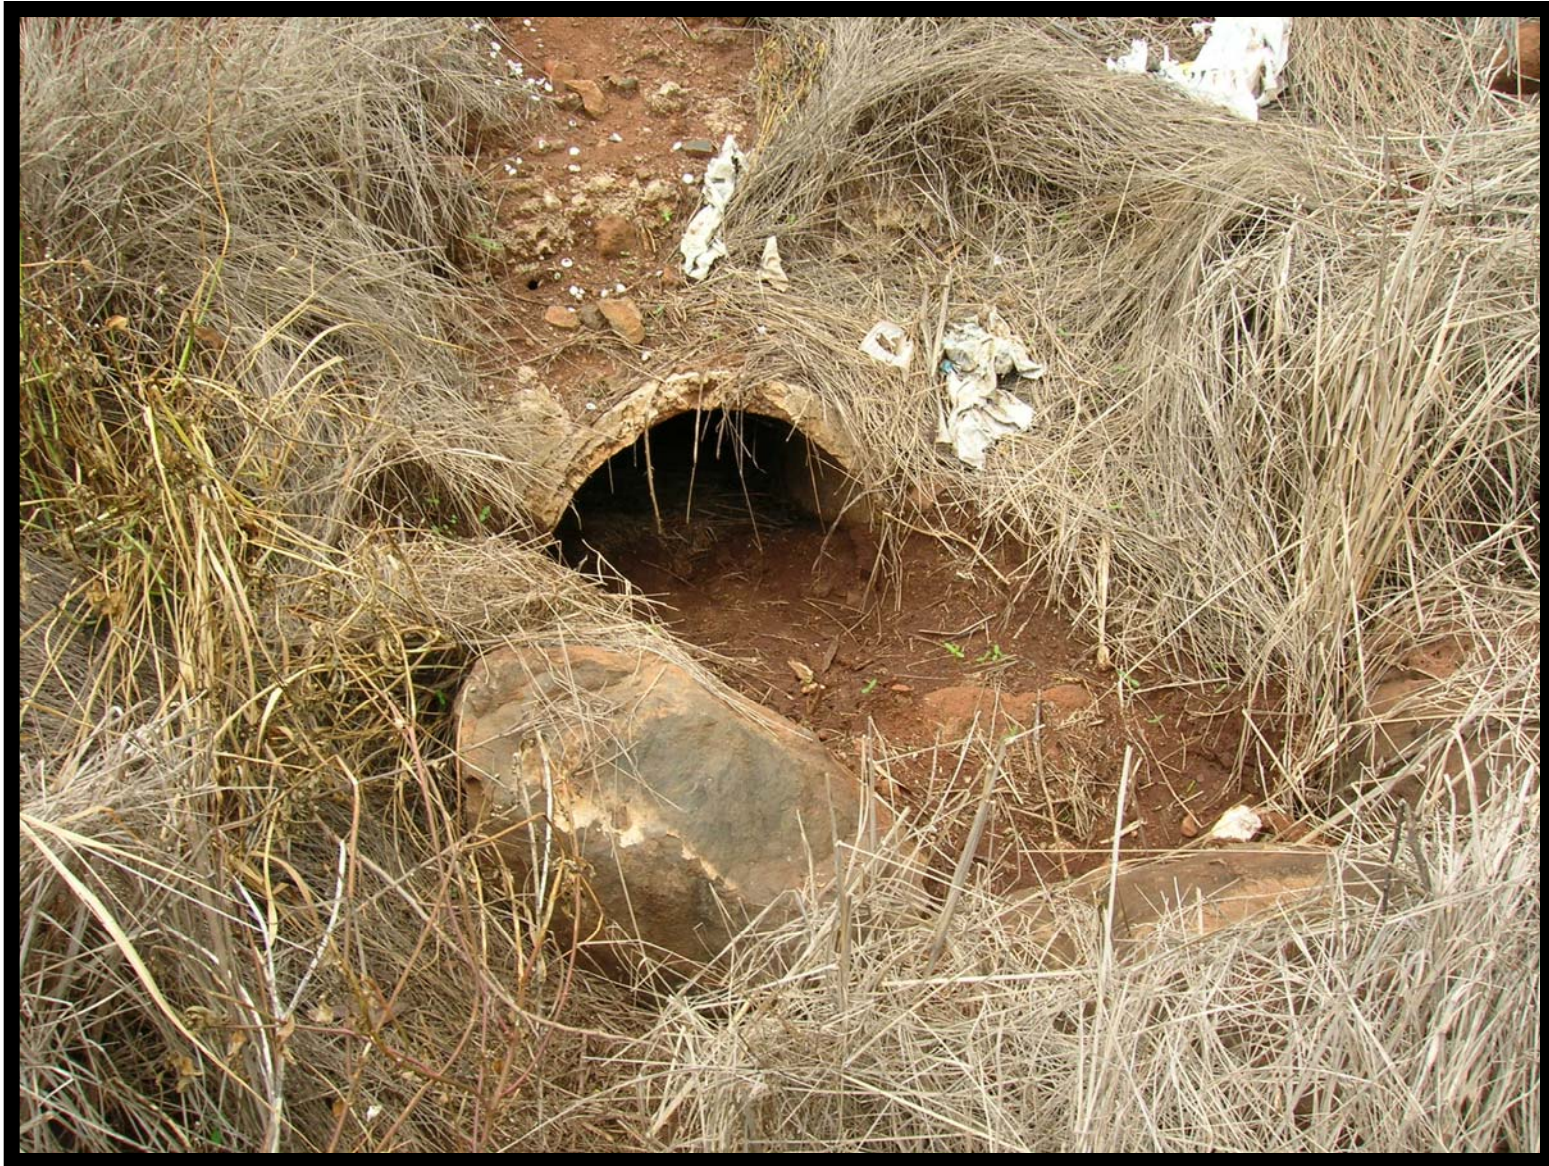
085 spillway conduit - clogged with silt

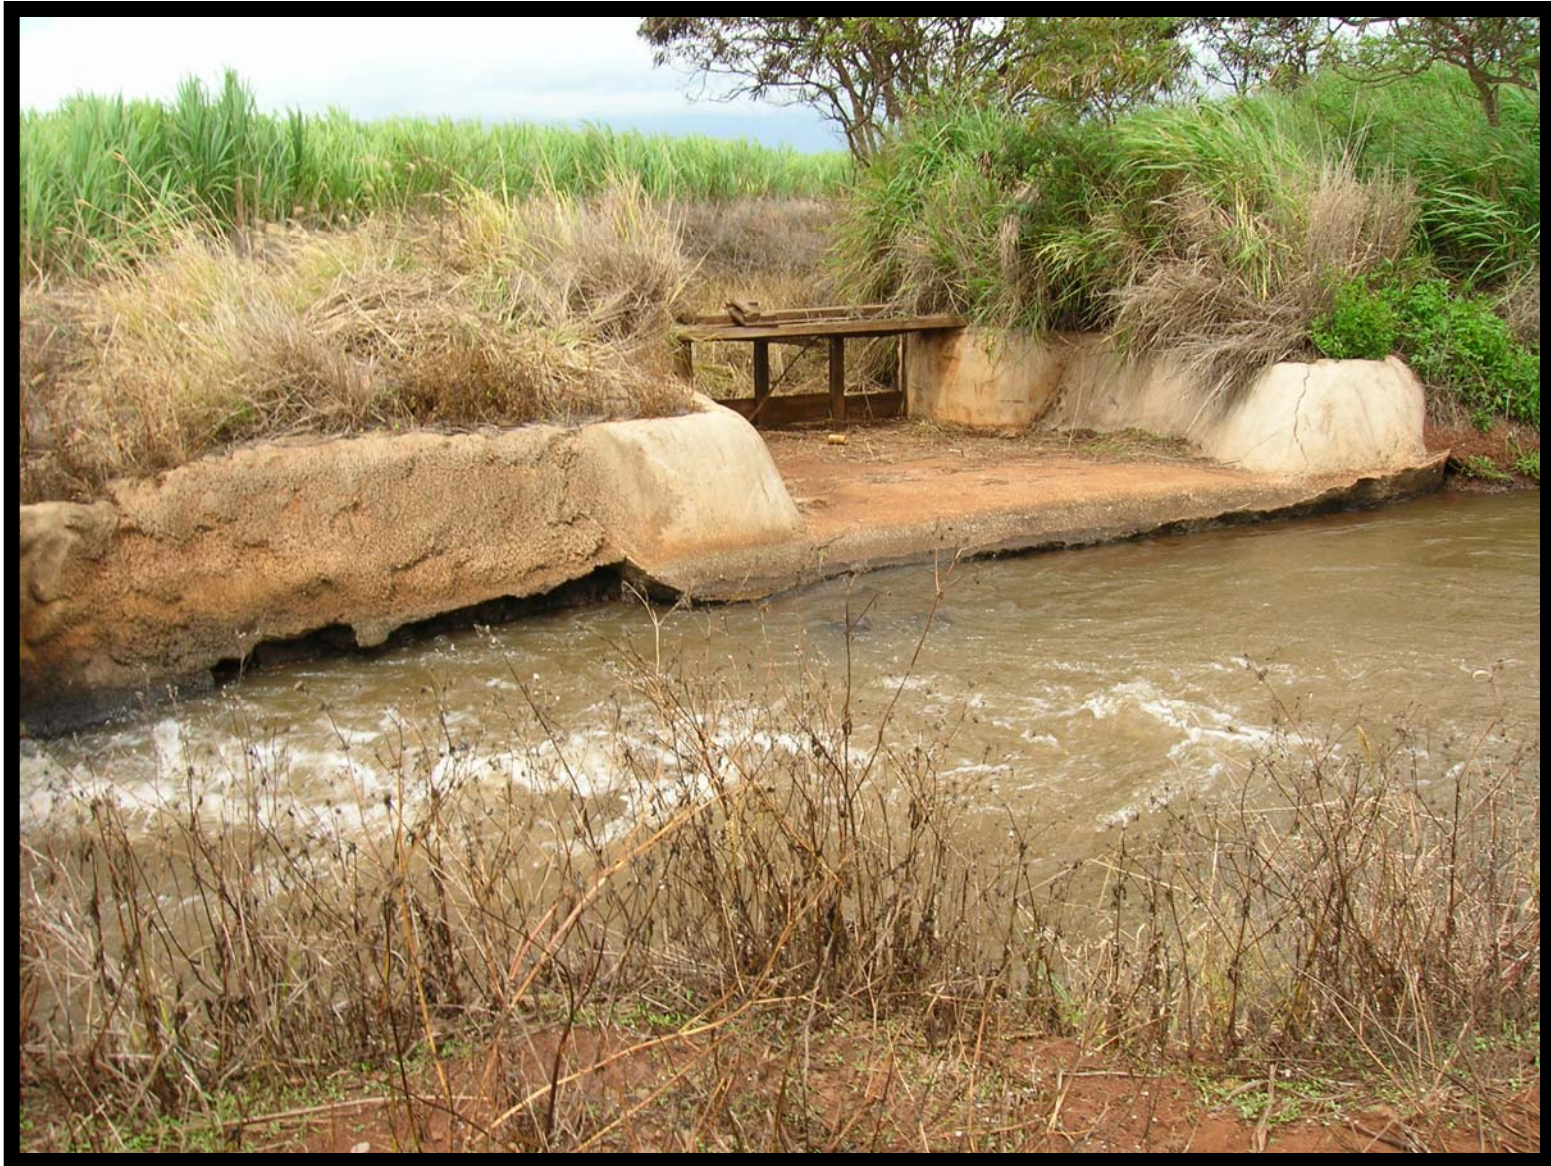
085 spillway

There was no erosion observed near the spillway.

- a. The Spillway appeared to be in fair to poor condition and requires corrective action.
- b. Unclear if spillway is adequately sized. Spillway should pass the probable maximum flood. Verify spillway capacity and take corrective action as required.
